MEMORANDUM

Subject: Comments on Sediment Stability in the Lower Passaic River based on analysis of side-scan Sonar, multibeam and single beam bathymetry, sediment samples and sediment probing.

From: Roger Flood, Stony Brook University

Date: April 28, 2008

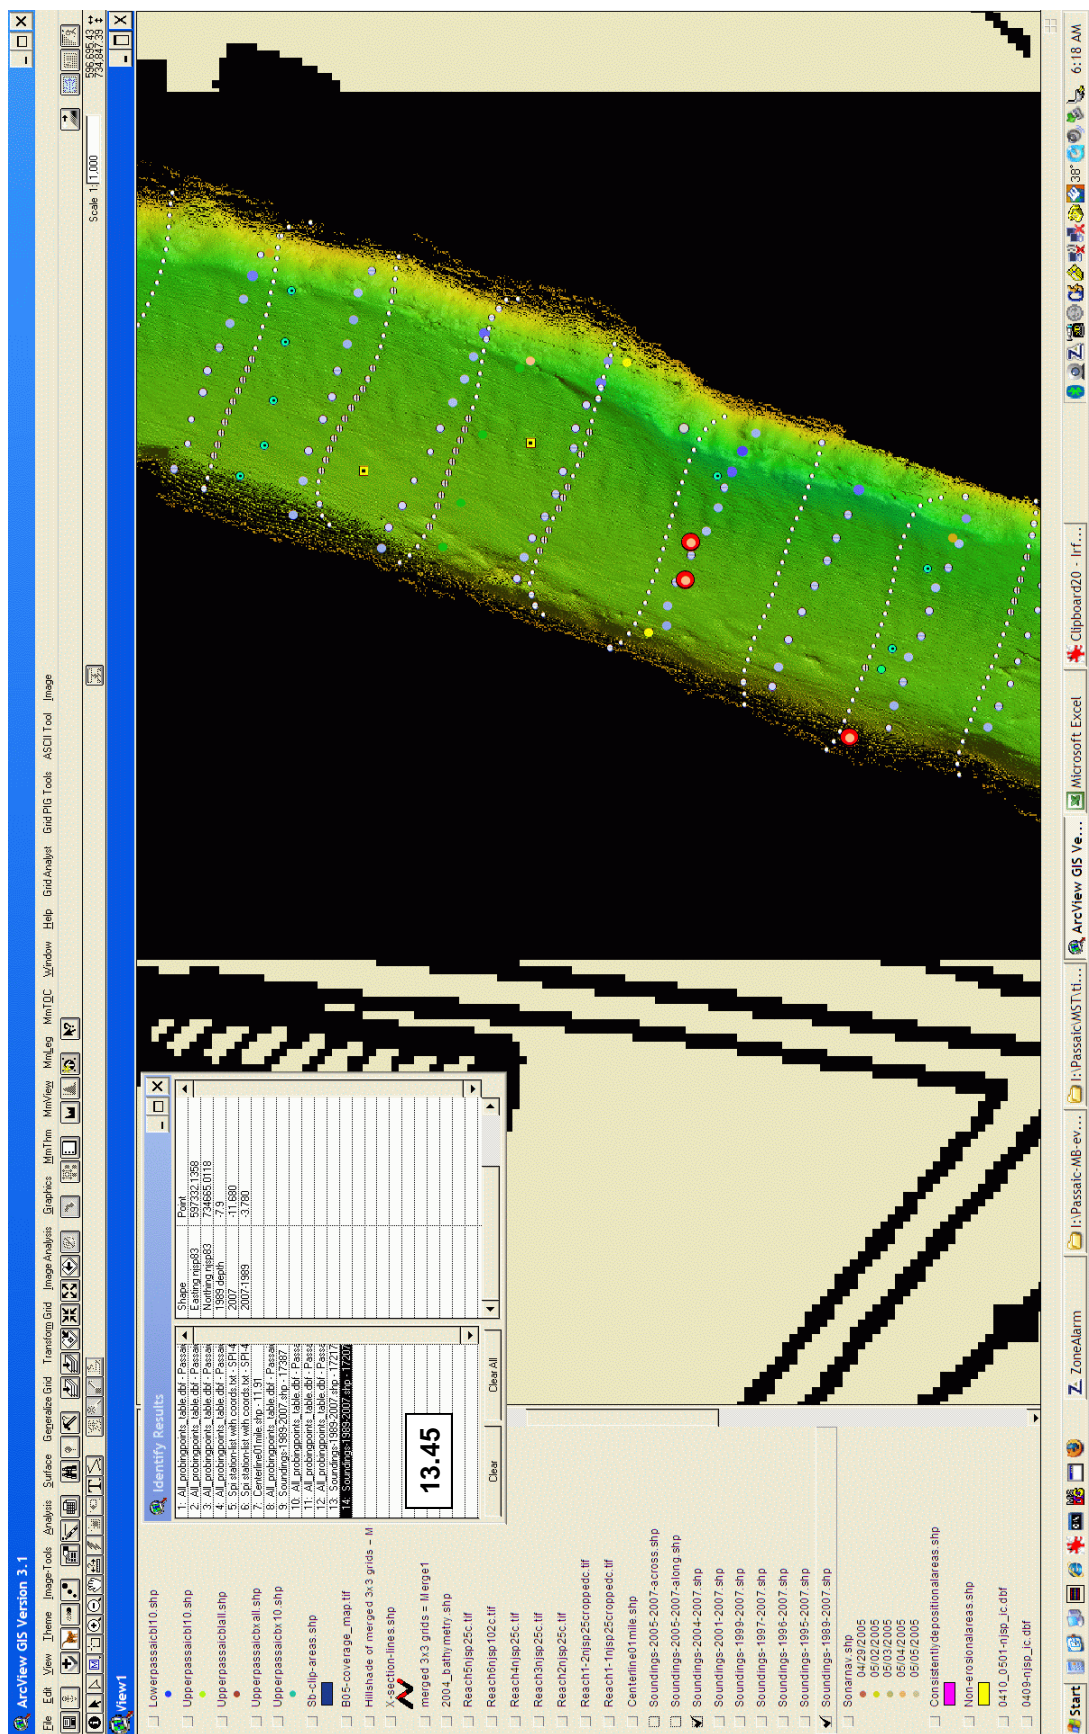
41	depth change 1989 to 2007 depth change 2004 to 2007 probing results DESA sediment analysis sun-illuminated 2007 multibeam depth	
	42	depth change 1989 to 2007 probing results DESA sediment analysis side-scan sonar 2005 images	
	Conclusions: The Passaic River at RM 13.45 had a depositional morphology in 2007, even though there was apparent net erosion from 1989 to 2007 and the mounded channel floor was not exposed in 2005. In this area the side-scan and multibeam morphological data are still consistent with the suggestion that sandy sediments can move through the system, possibly covering and uncovering sandy silt sediments.
